# Electric dryer defective drive belt Replacement

## INTRODUCTION

One of the common problems with electric clothes dryers is a broken drive belt. It's quite easy to replace one: it will only cost you \$15-\$20 for the part and about 1 hour of your life

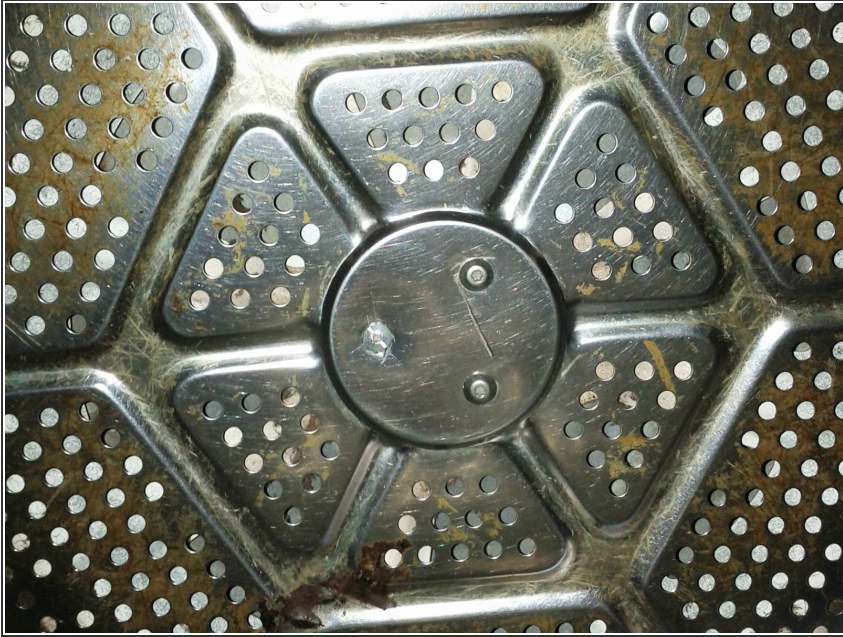
## Step 1 — defective drive belt

- There are many brands of electric dryers out there, but fortunately their construction follows just a few basic designs. The one I'm describing is a 20 year old Canadian Eaton model, but some of the inexpensive models sold today have the same construction.
- A good indicator that you are dealing with a similar model is the presence of three screws at the end of the drum, which you can see after opening the appliance door. In these appliances the drum is held in place by the axis connected by the three screws you can see in the picture and the friction pads at the front panel of the dryer.
- The first thing you will want to do is reach behind the dryer and unplug it from the electric outlet.

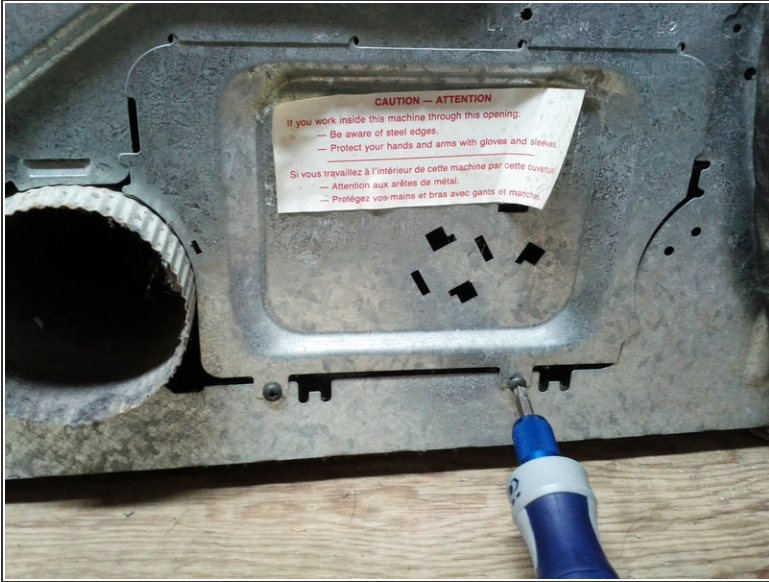
## Step 2

- If the belt is not yet completely broken, you will need to disengage it from the motor and the tensioner. To do that, unscrew the service door at the back.
- Inside the door you will see the drive belt, wrapped around the motor pulley and the tensioner. Reach inside the appliance, push down on the tensioner lever, and disengage the belt. Be careful not to cut yourself: there are sharp metal edges all around.

To reassemble your device, follow these instructions in reverse order.
